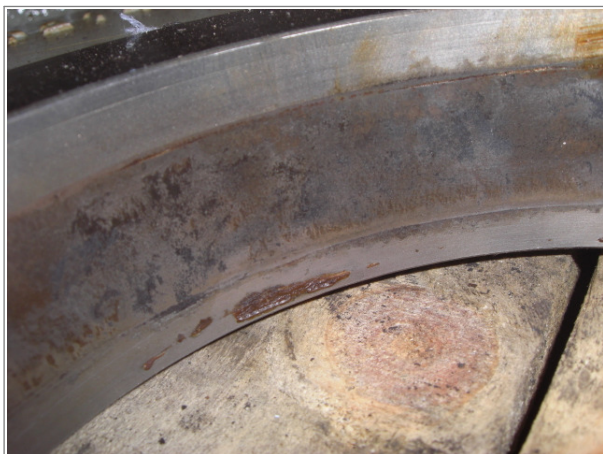
Fretting seen on NDE bearing housing (oversize on inspection)

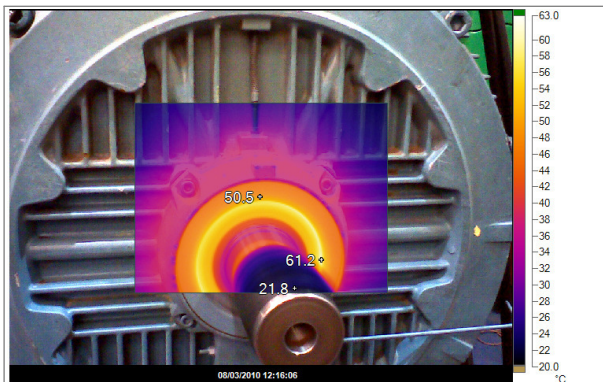
Bearing temperature plateau reached after 36 minutes operation 50.5 Degrees C
