# Electro - Mechanical Repair Report

Description 900 Kw AC Motor

Make ABB

Model M3BP 450LB 2 B3

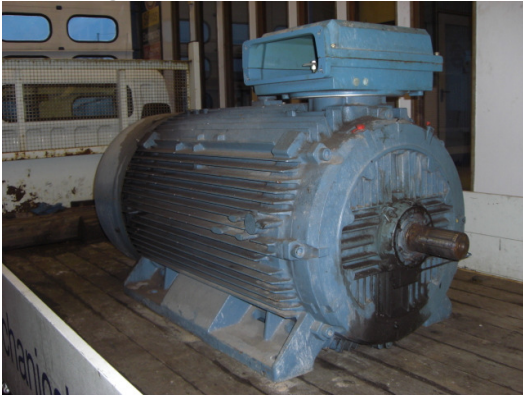
## Incoming Photo

Higher than normal vibration on the motor non-drive end

Vibration on band 2 (Rotational freq) is higher than the customer allowed amplitude levels. Most noticeable on position 1 (NDE) motor.

Bearing defect frequency amplitude band 5 levels high on DE & NDE

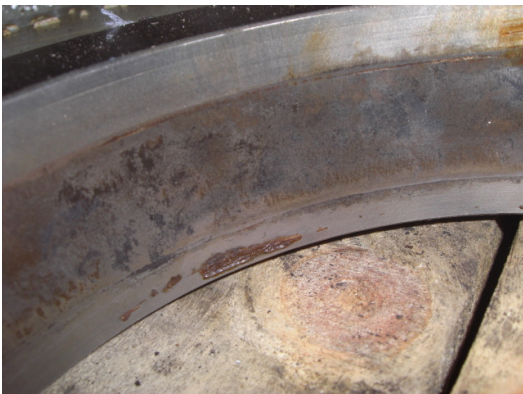
## Failure Photo

The NDE bearing housing is oversize @ 180.100 mm (@ 23 Deg C) tolerance for this fit is 180.000 - 180.025mm

The NDE bearing housing was found to be worn and measured above top tolerance by 0.075 mm.

NDE bearing housing measurement after repair 180.010 mm

The motor was stripped and all component parts were cleaned. The windings were checked for condition and integrity (Resistance, IR, HI-POT, Baker Surge, Inductance & Ground capacitance). All mechanical fits were measured and the dimensions were recorded. The NDE bearing housing was oversize, this was bored, sleeved and machined to a size of 180.010 mm. All parts were blast cleaned. The rotor was balanced to an enhanced G1.0 balance grade for reduced vibration operation. The bearings were fitted in accordance with SKF fitting procedures, the bearings and grease pipes were filled with fresh lubricant. A new 3Kw force blower motor was supplied and fitted to the cowl. The motor was assembled and test run at 60Hz for an output shaft speed of 3600 rpm (as per customer requirement)  
All electrical and mechanical test measurements were recorded and documented

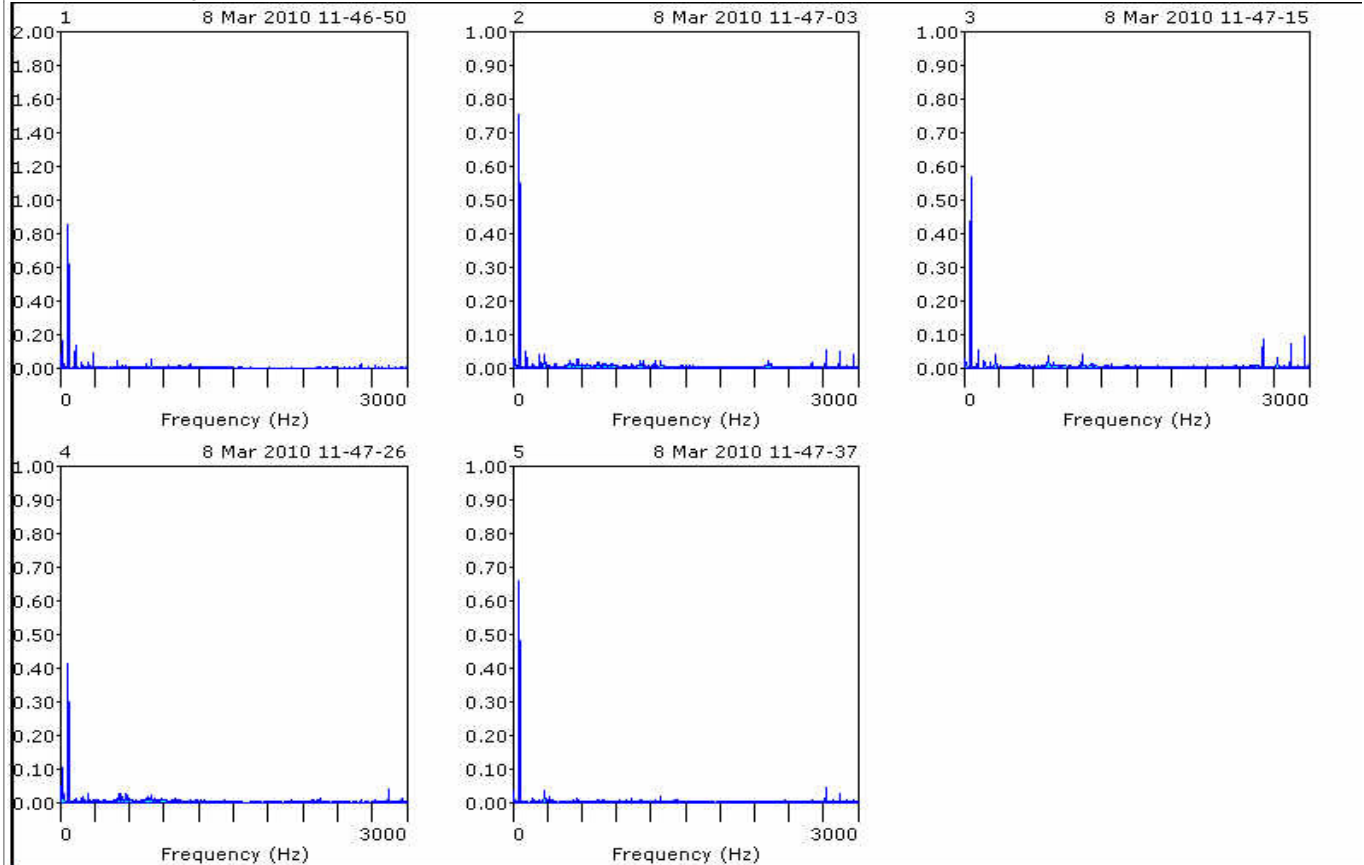
## Vibration Analysis

Customer specific vibration band data.

All results within specified limits

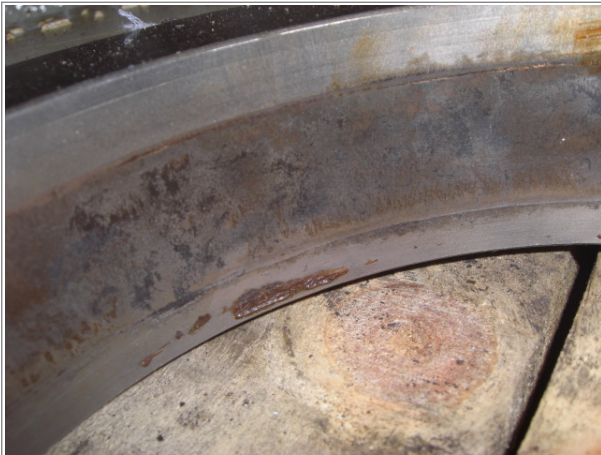
Fretting seen on NDE bearing housing (oversize on inspection)

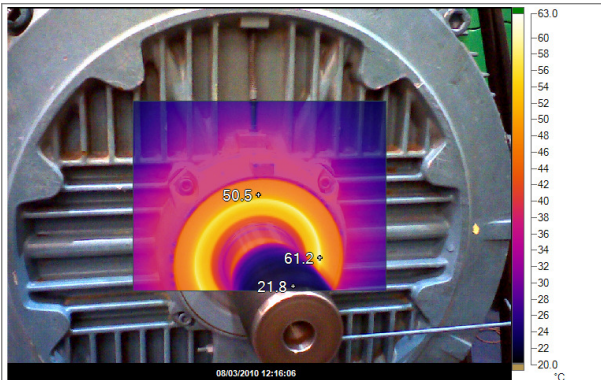
Bearing temperature plateau reached after 36 minutes operation 50.5 Degrees C
