# Electro - Mechanical Repair Report

Description 900 Kw AC Motor

Make ABB

Model M3BP 450LB 2 B3

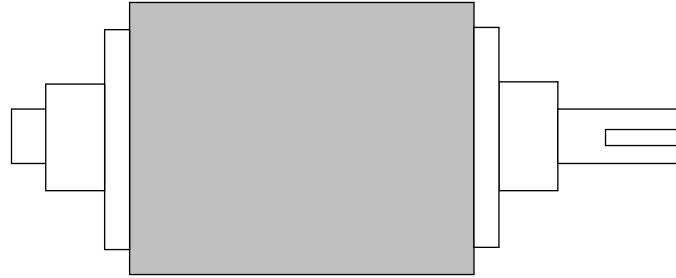
The NDE bearing housing is oversize @ 180.100 mm (@ 23 Deg C) tolerance for this fit is 180.000 - 180.025mm

The NDE bearing housing was found to be worn and measured above top tolerance by 0.075 mm.

NDE bearing housing measurement after repair 180.010 mm
